FMC Report No. 4686

DESIGN, FABRICATION, AND TESTING OF A COMPOSITE HULL FOR A TRACKED AMPHIBIOUS VEHICLE

Final Report

Prepared Under Contract No. N00167-84-C-0024 for **David Taylor Research Center**

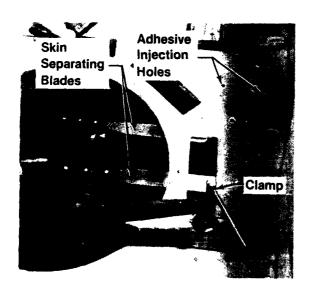
Figure 6-8. Upper Hull Skin Repair

We chose the Beta Mate 57/541-543 (Appendix A-29) because it was the only one of the group that produced 100% laminate failures (as opposed to bondline failures) when rebonded samples were tested in short beam shear. Techniques were developed and executed for the injection of adhesive and simultaneous clamping of areas where adhesive flow was not desired (i.e., the foam core areas). The only skin-to-skin contact areas that were not rebonded were areas adjacent to some hatch cutouts where bolts secured the final assembly. Figures 6-8 and 6-9 show the preparation for and injection of adhesive in the area of the driver's hatch.

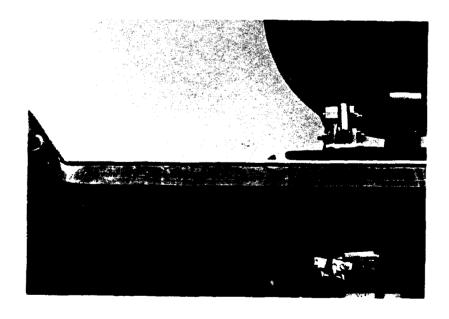
Figure 7-7. Trimmed Edge of Cargo Hatch Opening--No Visible Deterioration
